Advanced Home Inspections

Inspection Report

321 Easy St
Vero Beach, FL 32963
Prepared for: Sample Report

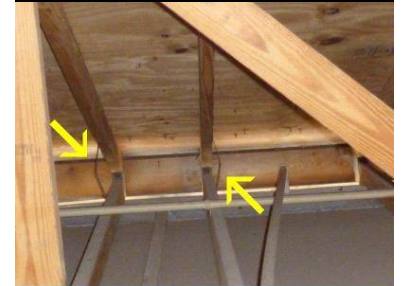
A few truss straps have excessive slack where fastened to top and bottom chord.

Truss strap slack

Recommend structural engineer determine repairs or replacement as needed. Also, this condition does not meet the wind mitigation standards, which will prevent a discount credit.

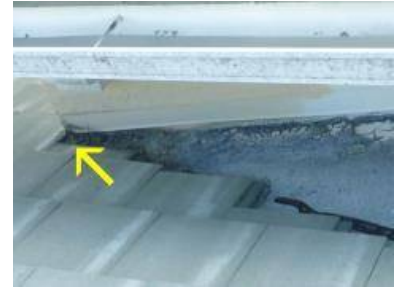
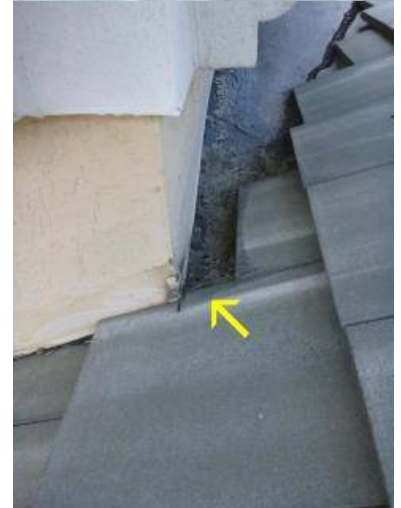
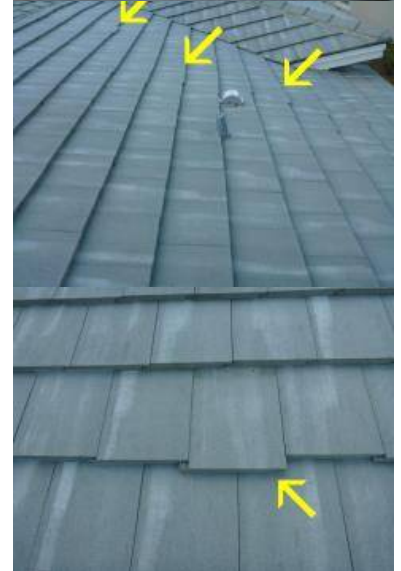
Some tiles are not properly secured to roof, adhesive used to secure tile to roof, is no longer sticking to roof membrane, allowing the tile to slide.

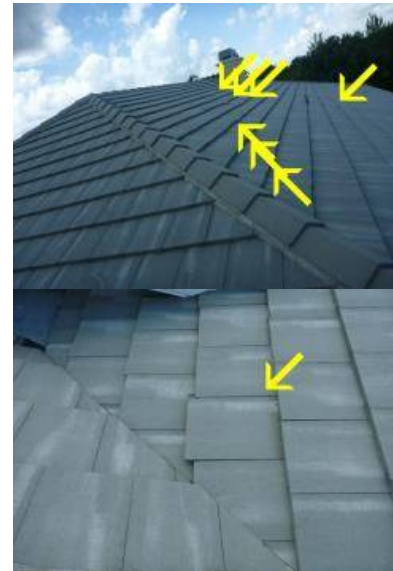
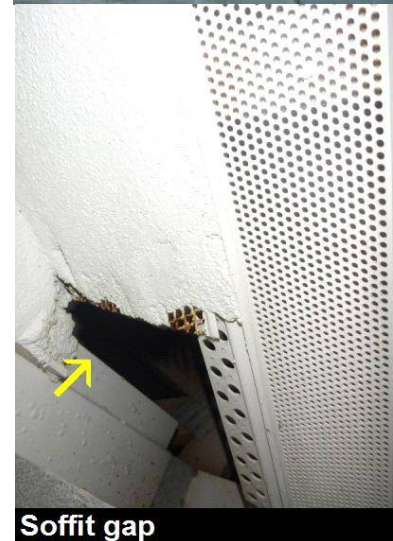
Roof is not properly sealed, there are gaps between roof and front entry return soffits, this is an area that can allow rodents to enter attic area. This condition is noted at the juncture of soffit and roof covering of the . Normally, these areas are sealed with an aluminum hardware cloth.

2001 Florida Building Code-§2309.7.3 All openings into the attic space of any habitable building shall be covered with screening, hardware cloth or equivalent to prevent the entry of birds, squirrels, rodents, etc. The openings therein shall not exceed 1/4 inch (6.4 mm).

Soffit gap

A licensed roofing contractor should be called to determine repairs or replacement as needed.

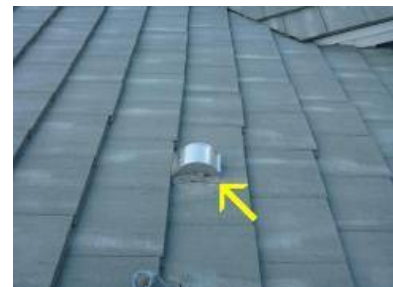
TYPE AND CONDITION: The dryer vent outlet is not designed for tile roof use. As a result the existing outlet is too short in height, the outlet's opening is partially blocked by the tile, which will restrict proper ventilation.

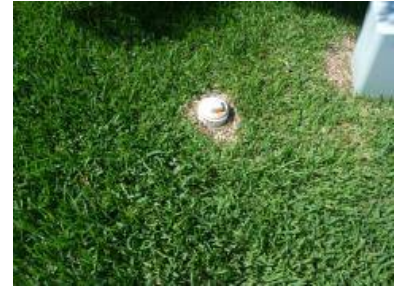
MATERIAL: Plastic.
CONDITION: Industry standards require proper protection of plumbing pipes. Sewer cleanout is above grade and subject to damage, recommend lowering to grade level.

2001 Florida Building Code-§P708.3.5 Building drain and building sewer junction. There shall be a cleanout near the junction of the building drain and the building sewer. The cleanout shall be either inside or outside the building wall and **shall be brought up to the finished ground level**

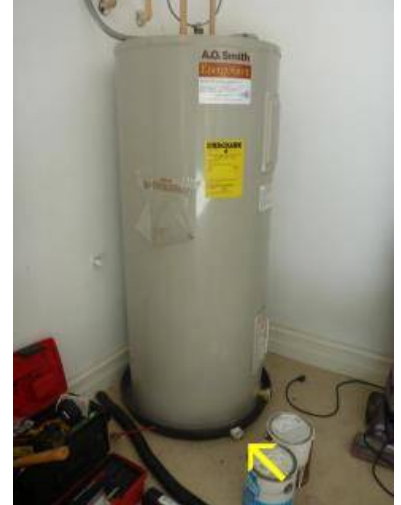
Water heater is located in the garage, on a raise area that is the same level as the living area, and is not provided with a drain line from the emergency overflow pan. These pans with their drain lines act to prevent damage to carpeting and furnishings, should the unit begin leaking. Recommend either installing an exterior drain line or water sensor alarm to drain pan.

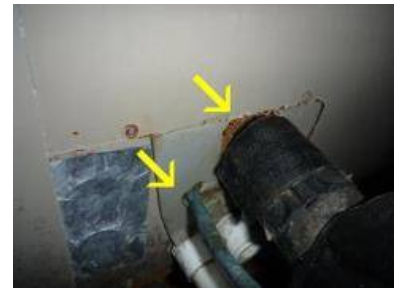
Air leakage is noted at various penetrations, this condition does not meet industry standards. Air handlers located in an unconditioned area, must be 100% sealed including all penetrations and service panel seams. Penetration should be sealed with gaskets, grommets or putty and seams can be sealed with foil tape. This condition can allow hazardous garage air to enter the air system.

Florida Building Code §13-610.1.ABC.3.5 Air Handling Units. All air handling units shall be mechanically attached to other air distribution system components. Air handling units located outside the conditioned space shall be sealed to 100 percent closure using approved closure systems conforming to the approved closure and mechanical application requirements of §13-610.1.ABC.3.1.

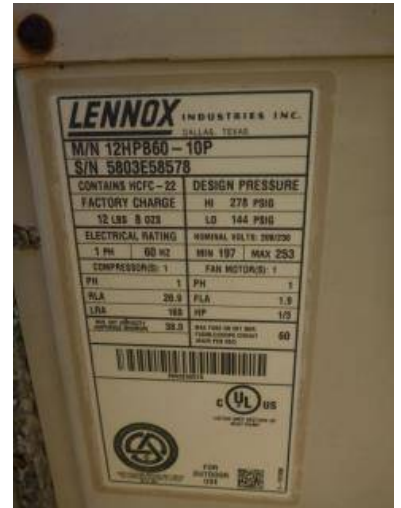
CONDITION: Unit makes unusual noise during operation - Recommend further evaluation.

Corrosion damage is noted. Although A/C unit may be operating as intended, due to the damaged condition, replacement may be necessary in the foreseeable future. Also, the corrosion damage will cause the unit to operate less efficient. When unit is replaced, recommend replacing unit with a more corrosion resistant unit.

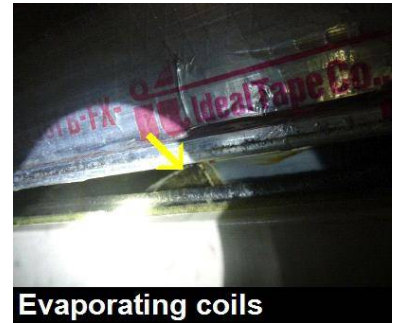
EVAPORATING COIL: Inside air handler cabinet. The evaporating coil is dirty and will not effectively remove humidity, which is the primary purpose of an air conditioning system. The evaporating coil should be cleaned by a licensed HVAC contactor.

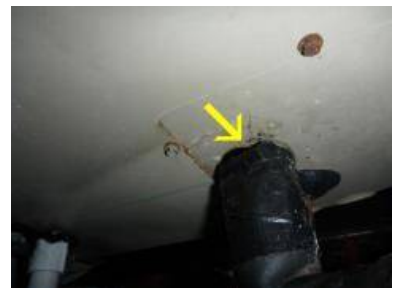
AIR HANDLER CONDITION: Air leakage is noted at various penetration, this condition does not meet industry standards. Air handlers located in an unconditioned area, must be 100% sealed including all penetrations and service panel seams. Penetration should be sealed with gaskets, grommets or putty and seams can be sealed with foil tape.

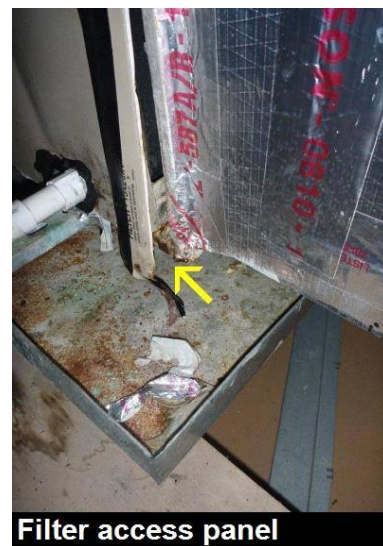
Filter access panel screw is stripped and no longer secures panel to air handler cabinet.

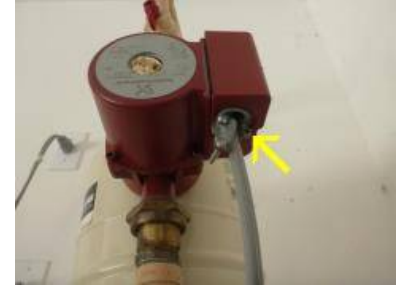
Hot water recirculation pump power cord is no longer properly secured to pump junction box.

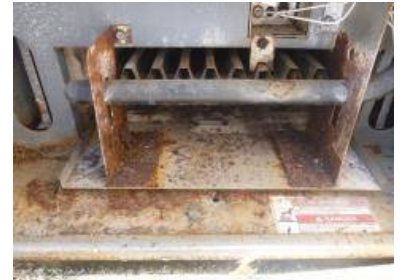
TYPE AND CONDITION: LP gas, Appears serviceable Burning chamber has some rust damage, A qualified pool equipment contractor should be called to make further evaluation and repairs as needed.

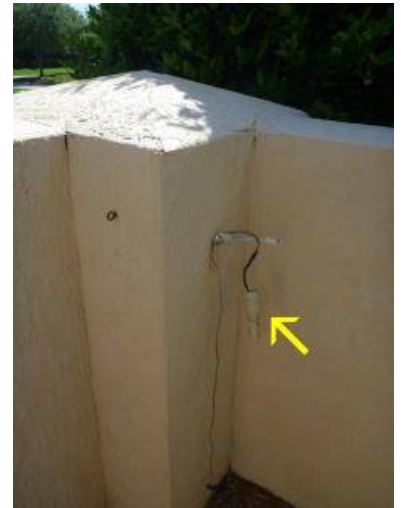
TYPE & CONDITION: The required rain sensor is not properly installed. The rain sensor should be installed in a location to capture rain, however, the existing sensor mounting bracket is broken.
