Advanced Home Inspections

Inspection Report

321 Easy St
Vero Beach, FL 32963
Prepared for: Sample Report

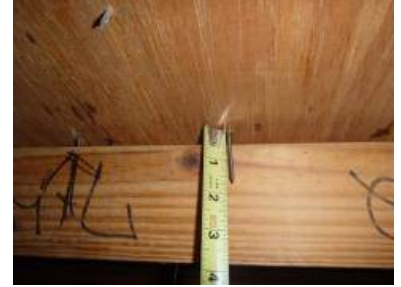
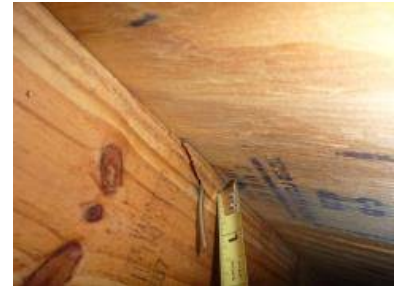
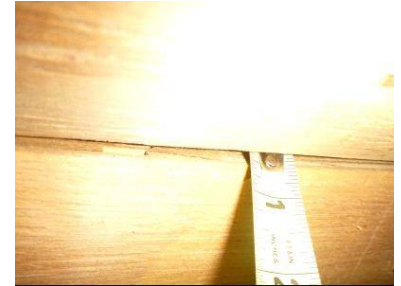
A few truss straps have excessive slack where fastened to top and bottom chord.

Recommend structural engineer determine repairs or replacement as needed. Also, this condition does not meet the wind mitigation standards, which will prevent a discount credit.

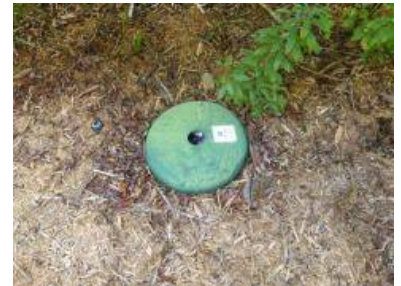
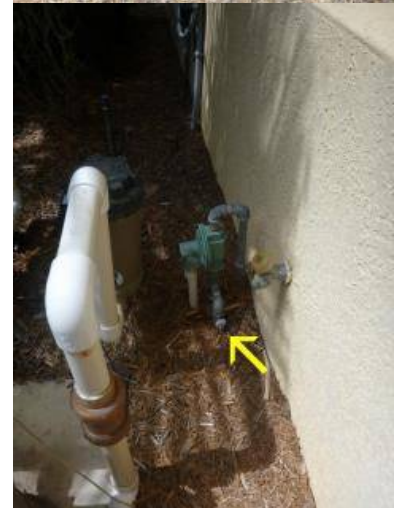
LPG/Oil tank located in the left side yard and shut off valve is located on left side wall near pool equipment.

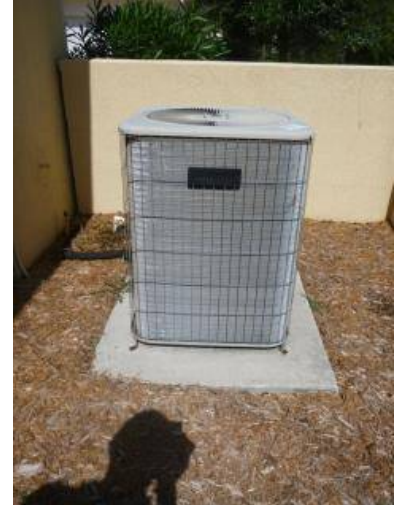
TYPE: Central Air, North Wall, West Unit.

MANUFACTURER: Lennox.
MANUFACTURED DATE: 2003
AIR CONDITIONER AGE: Air conditioning systems of this type have expected service lives of 10 to 15 years. Any component of a central cooling and heating system which is over 10 years age is categorized as being in fair condition, primarily due to its increased likelihood of breakdown and need for replacement in the future. Any service life in excess of 15 years is in the realm of good fortune only and should be viewed as such. Typically these older units have low efficiency rating and in many cases it is advisable to change out these unit for more energy efficient units with ratings of 13 to 16 SEER (Seasonal Energy Efficiency Rating).

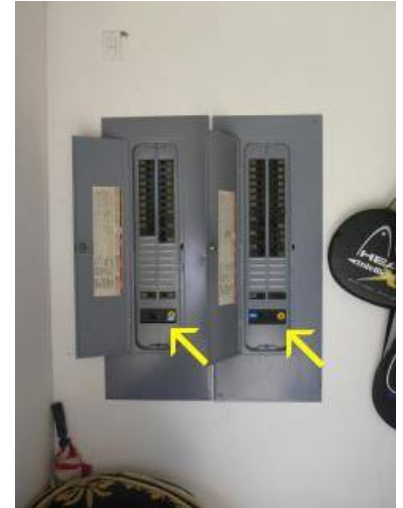
LOCATION: Panel.

SIZE: 150 Amps.
MANUFACTURER: Square D Breaker.
CONDITION: Appears serviceable.

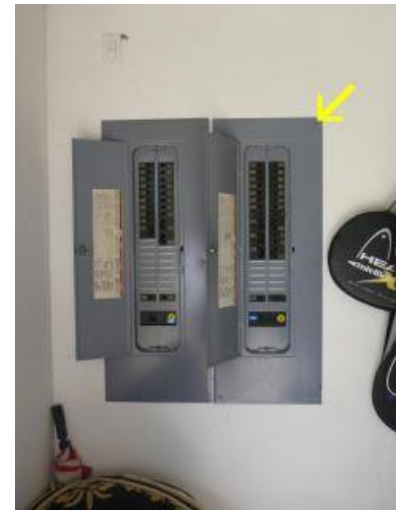
MAIN PANEL LOCATION: Garage, south interior wall, west panel.

PANEL RATING MANUFACTURER: Maximum panel rating is 200 Amps.
Square D Panel.

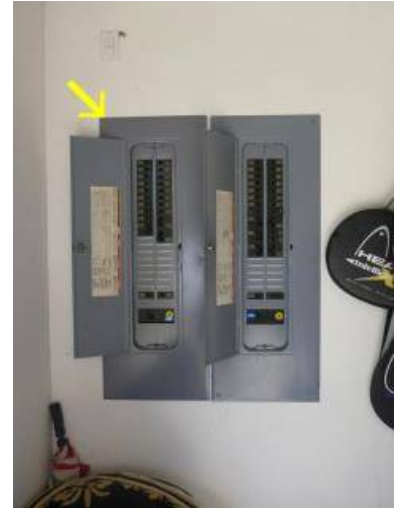
MAIN PANEL LOCATION: Garage, south interior wall, east panel.

PANEL RATING Maximum panel rating is 200 Amps.
MANUFACTURER Square D Panel.
PANEL'S CONDITIONS Circuit and wire sizing correct so far as visible, Grounding system is present.

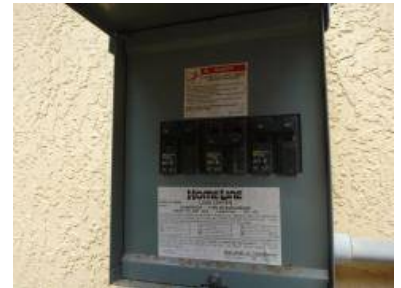
SUB PANEL LOCATION: Pool Equipment.

MANUFACTURER: Square D Panel.
PANEL RATING Maximum panel rating is 100 Amps.
PANEL'S CONDITIONS Circuit and wire sizing correct so far as visible, Grounding system is present.

Breaker labeled pool light conductors are disconnected.

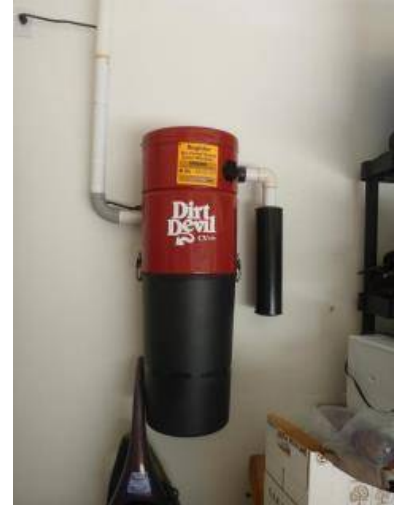
Appears to be serviceable.
